Investigating the Causes and Impacts of Gully Erosion in Auchi, Nigeria

Original Research Article

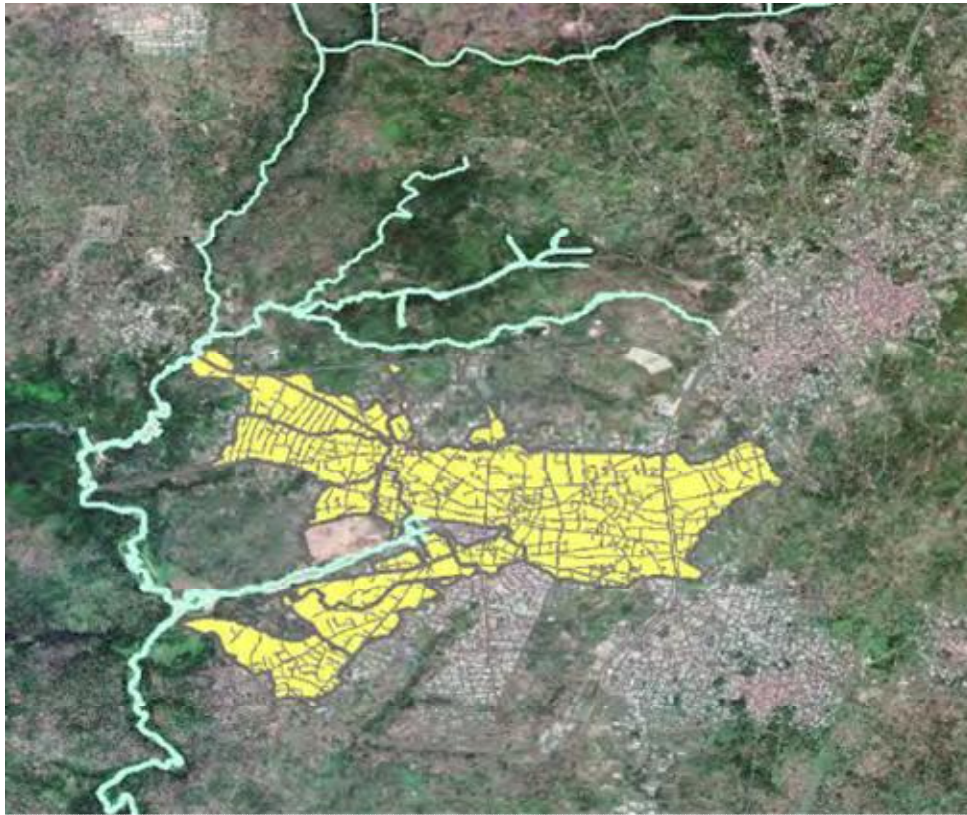
The boundary of the contributing crunch of the site as shown in Fig. 2, was delineated using the digital elevation model data obtained from the [3].

Fig. 2. Auchi satellite image and the catch basins that contribute to soil erosion
(Source: [3])

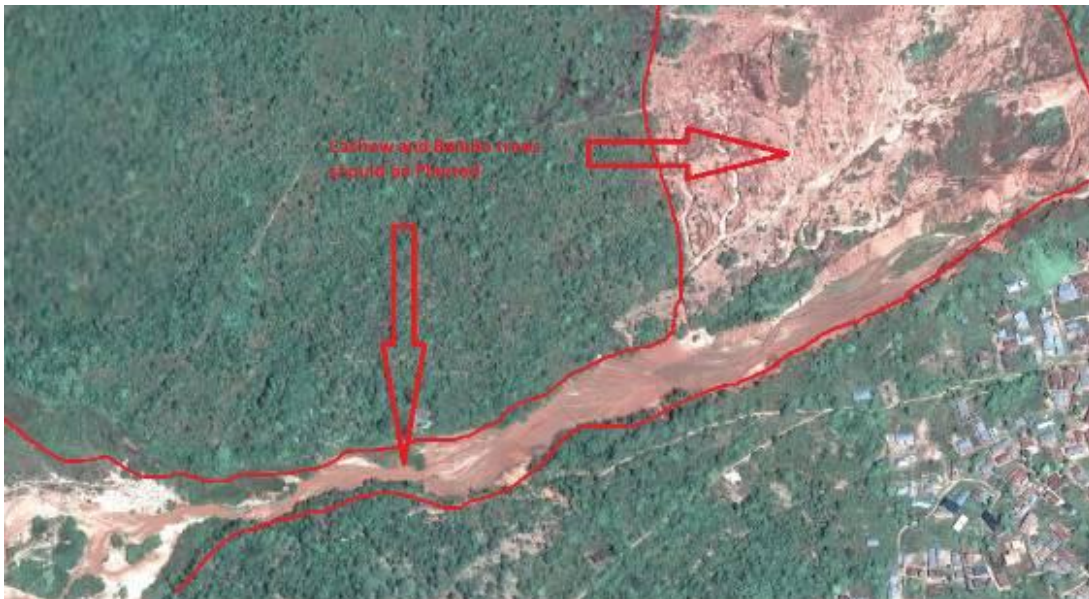
The remote sensed data are presented in Figs. 3-6. Fig. 3 shows erosion affected areas in Auchi town while Fig. 4 shows termination of drainage at the centre of the town.

Fig. 3. Image from remote sensed data showing erosion affected areas
(Source: [25])

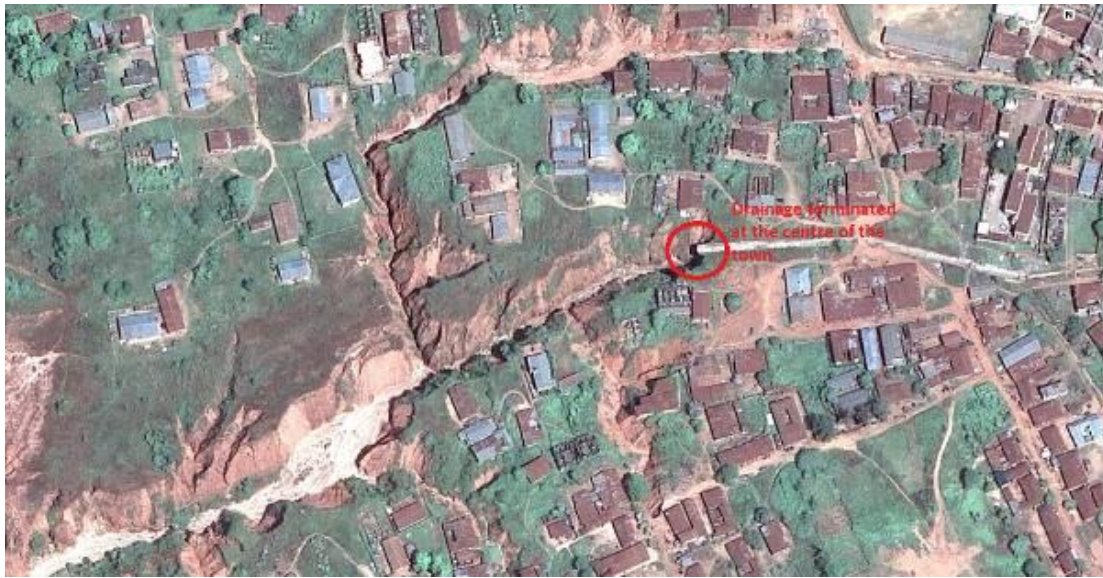
Fig. 4. Synoptic view from remote sensed data showing termination of drainage at the center of the town
(Source: [25])

the synoptic view of the affected area (Fig. 4) showed a deliberate and dangerous termination of a drainage right at the center of Auch town.

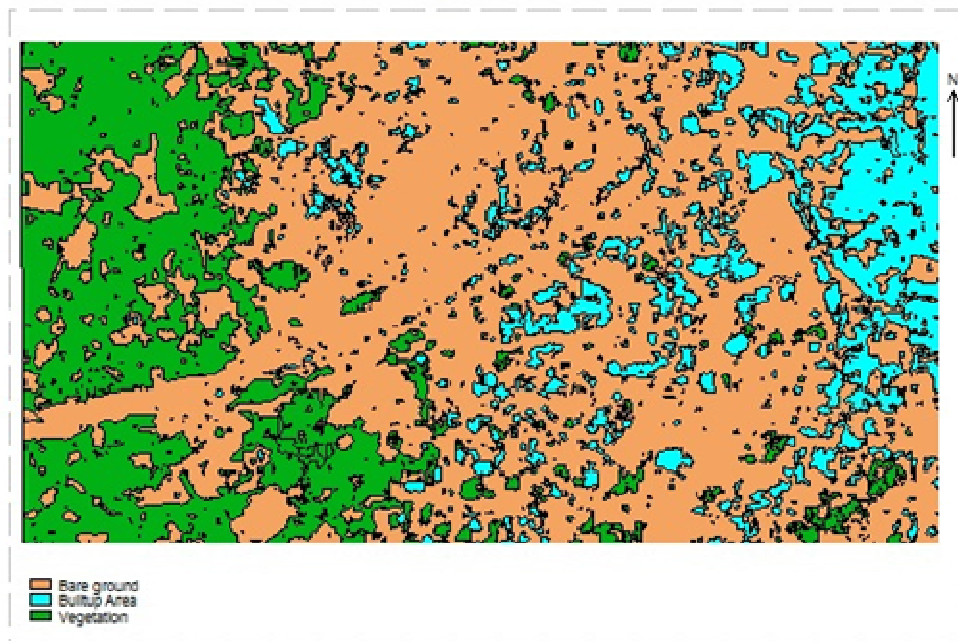
Fig. 5 is the Land cover map of Auchi area showing vegetation (Green patches), bare ground (Brown) and Built-up area (Blue patches). In Fig. 6, the areas vulnerable to threat of the gully have been clearly indicated on Fig. 5 to show built-up sites at risk. Therefore, Fig. 6 is showing settlements and facilities at 200 m buffer around the centre of the gully site which have been considered to be at Risk. It falls between Longitude $6^{\circ} 14' 26.93''$ and $6^{\circ} 15' 32.27''$, Latitude $7^{\circ} 04' 16.15''$ and $7^{\circ} 03' 42.31''$, respectively.

Fig. 5. Land cover map of Auchi area showing vegetation (green patches), bare ground (brown) and built-up area (blue patches)

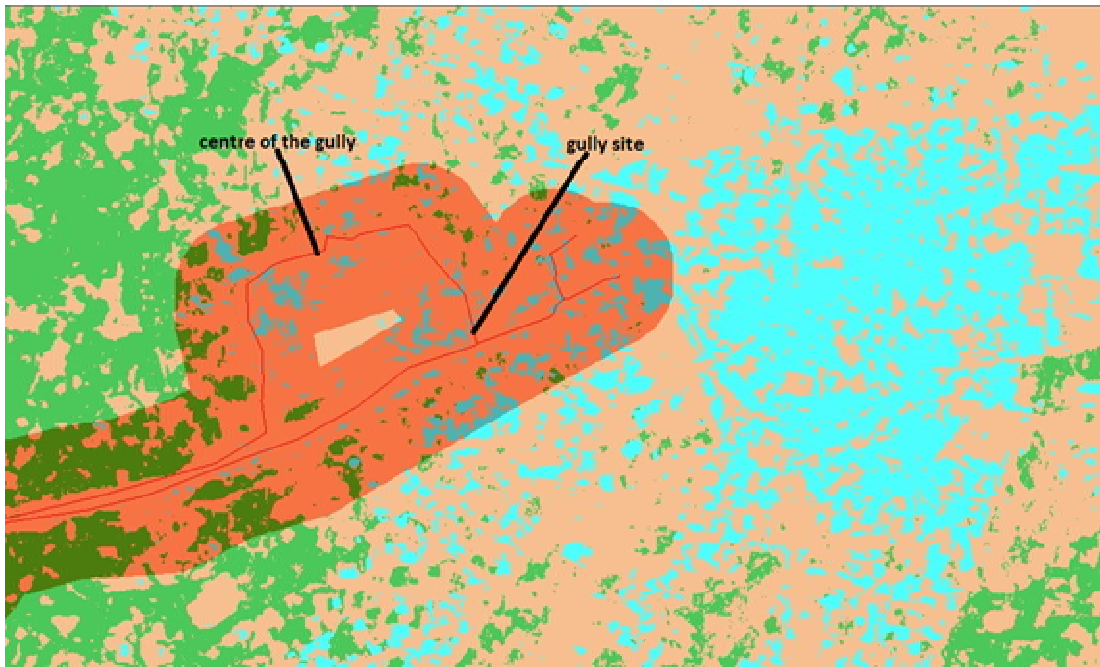
Fig. 6. Risk map of Auchi showing the centre of the gully (red thin line) within the gully site

The risk map, Fig. 5 clearly showed settlements and facilities at 200 m buffer around the centre of the gully site which have been considered to be at Risk. It falls between Longitude 6° 14' 26.93" and 6° 15' 32.27", Latitude 7° 04' 16.15" and 7° 03' 42.31", respectively.

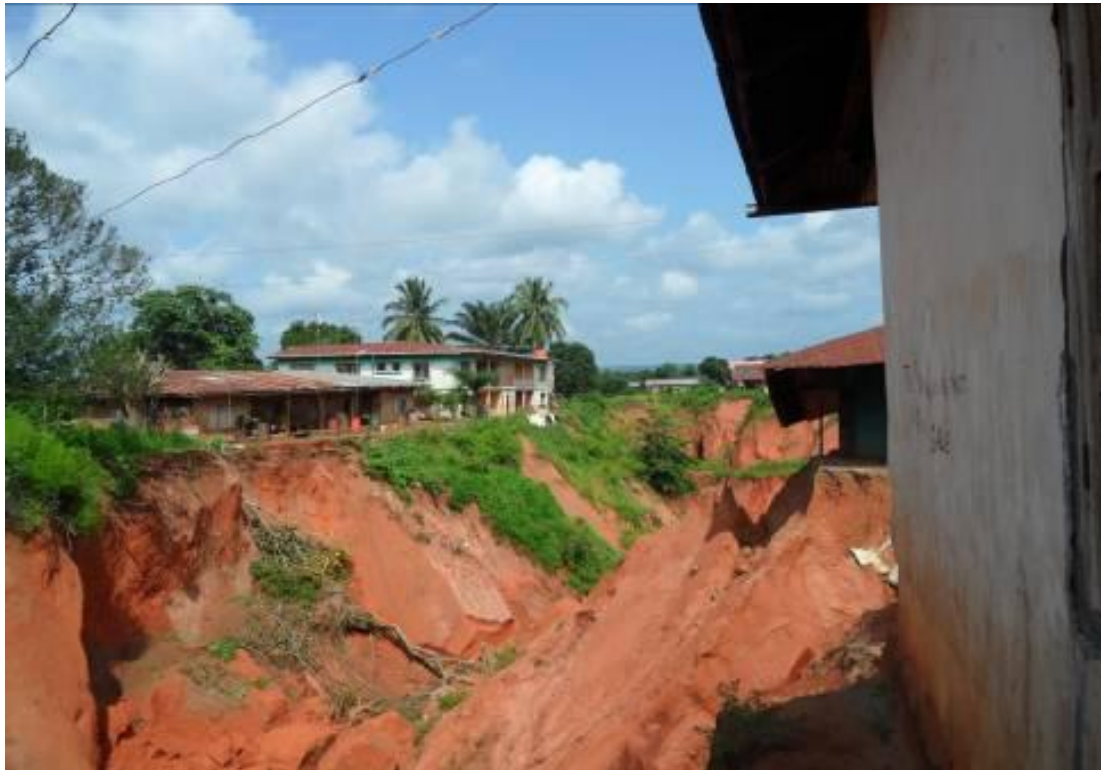
Fig. 7. Buildings about to be swallowed by gully erosion in Auchi

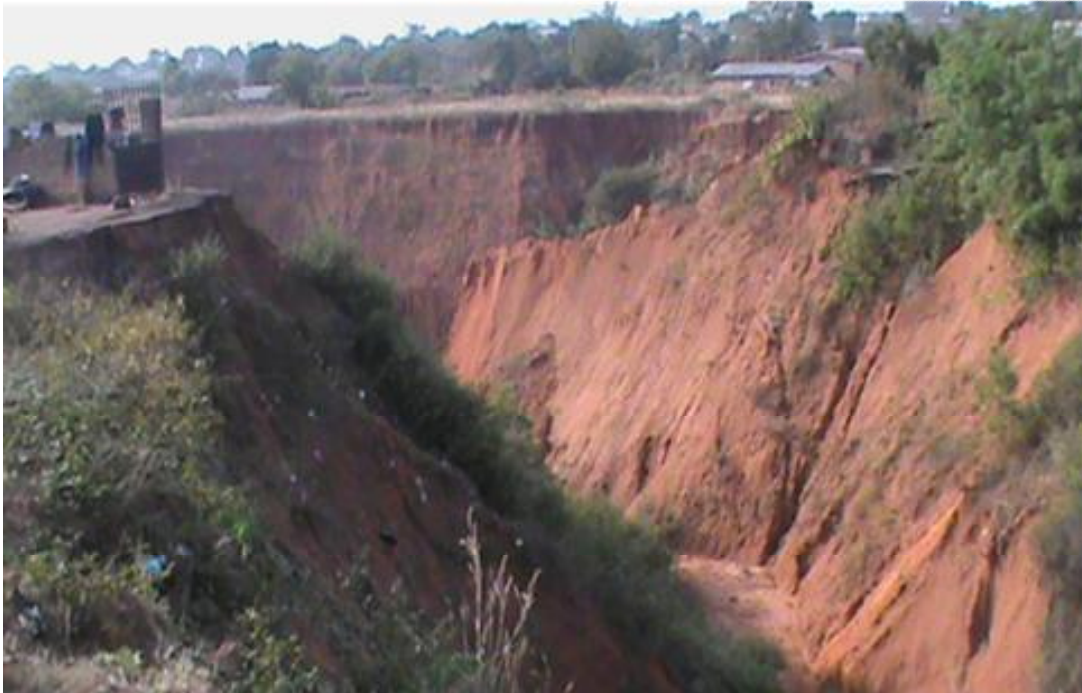
Fig. 8. A deep gully located within the study area

The main factors found to influence the extent of gullying include local geologic setting, depth to water table and annual rainfall. Others are permeability, porosity, cohesion and hydrodynamic events in the areas. The Auch erosion menace is thriving as a result of absence of well-coordinated control measures and inadequate and urgent attention it deserves. For instance, in spite of the devastating impact on humans and structures and potential threats on more structures if not well managed (Figs. 8-10),

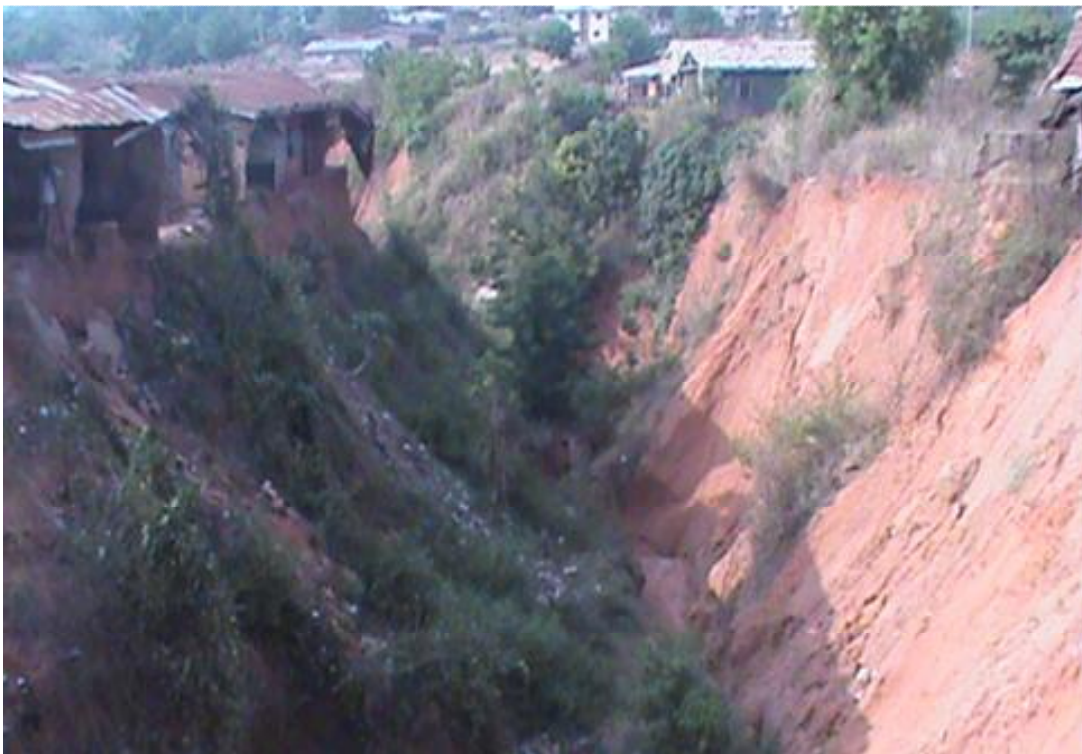
Fig. 9. Buildings under the threat of gully erosion in Auch

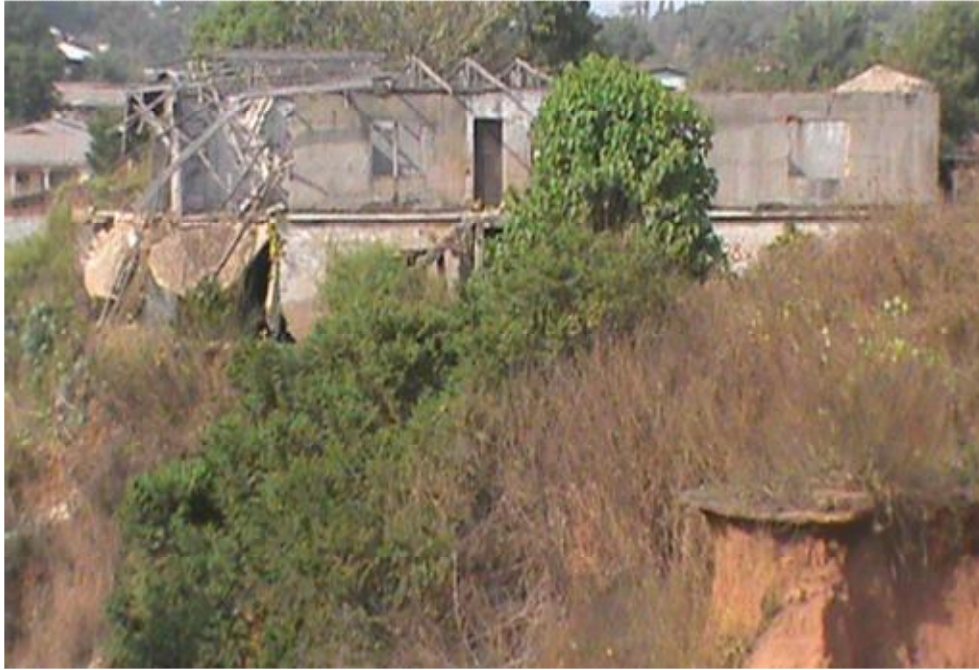
Fig. 10. A building damaged by gully in Auch
